## **Quality Test Report**

# Vision X Asia Lighting

MIL-PMX3060

Low temperature test

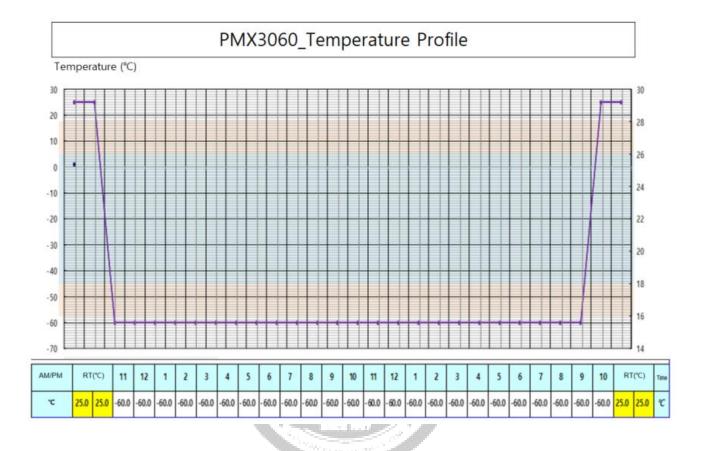
### - Temperature Profile

3. Leave the item at minus 60 degrees Celsius for an hour and check whether the item lights up as a pre-test. Start the main test, leave the item for 24 hours at minus 60 degrees Celsius.
